Hammond® B3/C3

HUM & NOISE Reduction

Hammond B3/C3 - Hum & Noise Reduction.

POWER SUPPLY UNIT (PSU) of AO-28 preamp.

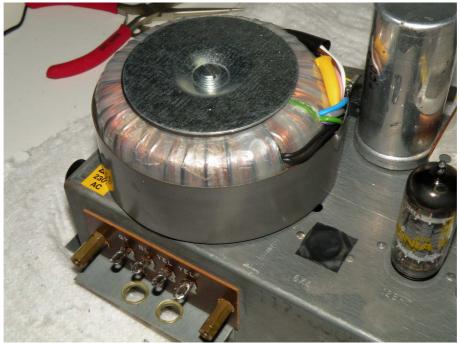
The installation of this toroidal transformer is quite easy. Only one hole has to be drilled.

A mumetal shield strip is added around the transformer to be 100 % sure that any magnetic leakage will be eliminated. This shield is grounded.

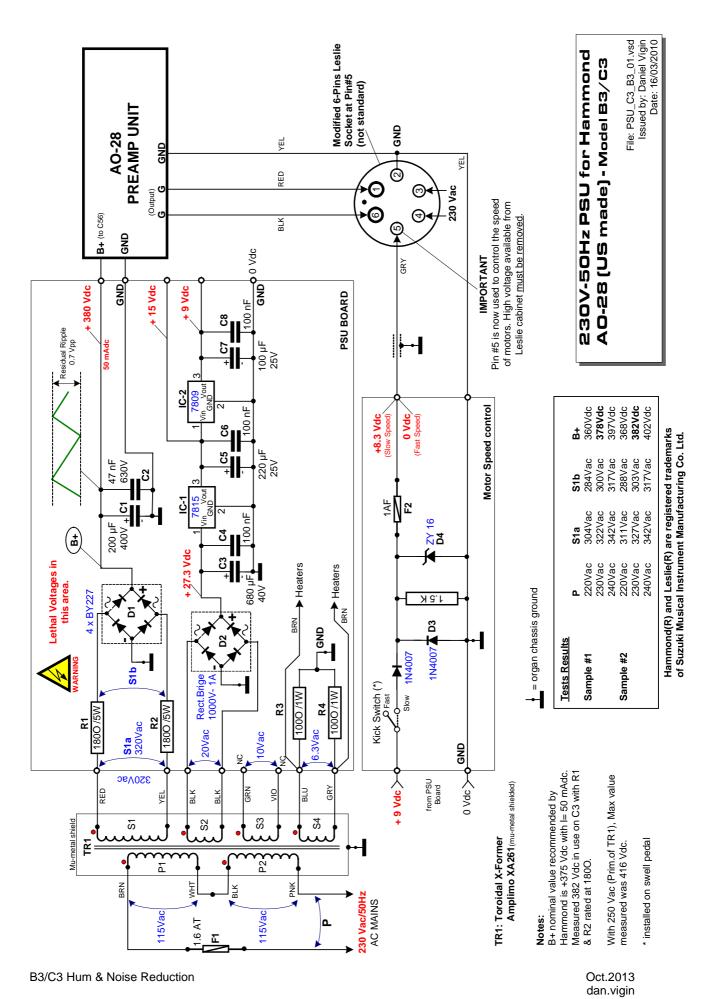
1. Toroidal transformer XA261.

<u>Primary windings</u>: composed of two windings P1 and P2 of 115 Vac each wired in series so that, from now on, the AO-28 preamp is directly connected into 230 Vac i.s.o. being fed by an external auto-transformer (at least for European market). Since Hammond Co has been always allergic to insert protection fuses in their organs, one 1.6 AT fuse was installed too.

<u>Secondary windings</u>: winding S1 (320 Vac) will provide the high voltage supply, S2 (20 Vac) will be used for low voltages applications and S4 (6.3 V) for heaters. S3 is not used.

Refer to schematic diagram on next page.

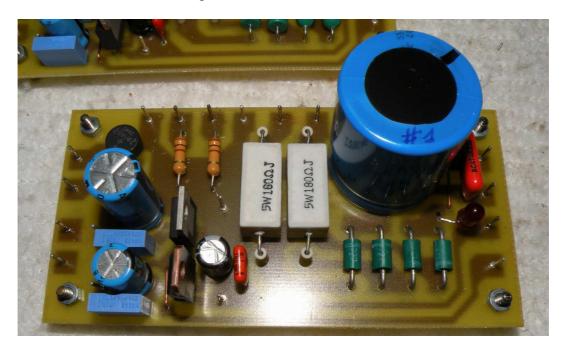
2. New AO-28 PSU.

The entire PSU has been redesigned and rebuilt on a dedicated PCB.

High voltage (B+): the original twin diode tube 6X4 is removed and is replaced by a rectifier bridge composed of 4 x BY227 diodes. However, to compensate the Rs value (also called plate supply resistance) of this rectifier tube, two wirewound resistors of 180 Ω /5W have been inserted in series as shown on the schematic diagram. Based on several trials, after rectifying, this value of 180 Ω provides the exact B+ voltage of +380Vdc. The first elco (C56, 40μFon Hammond schematic) is replaced by a new elco of 220 μF/400Vdc installed on PCB, this means more than 5 times higher value.

By doing this way, the residual ripple value will drop to 0.7 Vpp! It has been always a good engineering practice to shunt elco's with low value capacitors in the range of 100nF.

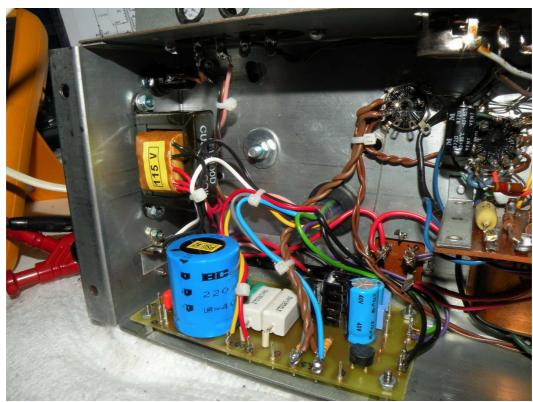
The new PSU circuit (120 x 60mm) is installed on the vertical side of the AO-28 chassis (TWG side). Wiring is extremely simple.

The tube socket of 6X4 tube (V8) has been unwired, only the heaters cabling remains as it (brown wires).

Installation of new PSU board inside the AO-28 chassis.

The small transformer on the left side of the picture is also installed inside the AO-28 chassis. This transformer is part of the Trek II String Bass SB2500A kit and is connected to one primary winding 115Vac of the newly installed toroidal transformer. There is room enough and by doing so any flux leakage will be blocked by the AO-28 metal chassis.

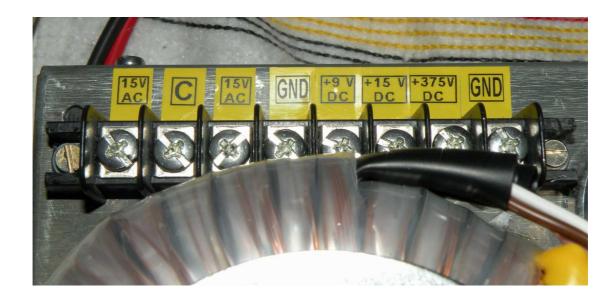
For easiness of voltage measurements and wiring, one 8-terminal connector is mounted on the AO-28 chassis (TWG side).

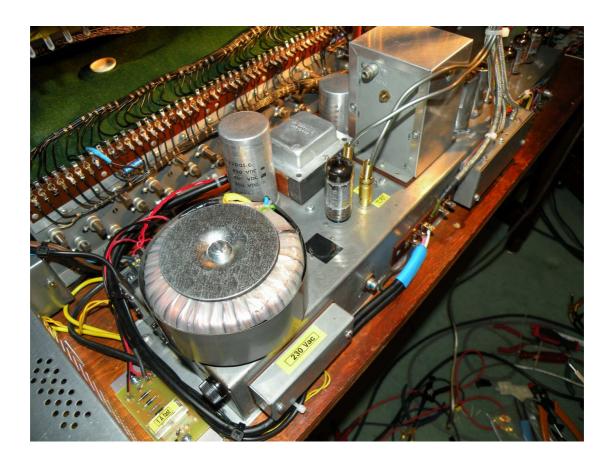
How it looks inside the B3/C3 when completed.

When watching this picture there are some more remarks that merit some attention.

- Fuse-holder is nearby the toroidal transformer (easy access).
- Links between the output transformer T3 (G–Bn–G) and Leslie 6-pins socket are also shielded, see twin black cable (no so easy on B3's).
- The 9-pin adapter into the 12BH7 (to Trek II Reverb RV-1C) tube has been removed and replaced professional CINCH plugs and sockets.
- An additional small PCB is installed for the motor speed control on the bottom left hand side of the picture. See next chapter 'Leslie Motor Speed control'.
- Rectifier tube 6X4 has been removed and socket covered.

The whole AO-28 Preamp Unit is now fed directly with 230 Vac (EUR) and the auto-transformer 230V/115V has been removed from the organ (less magnetic field).

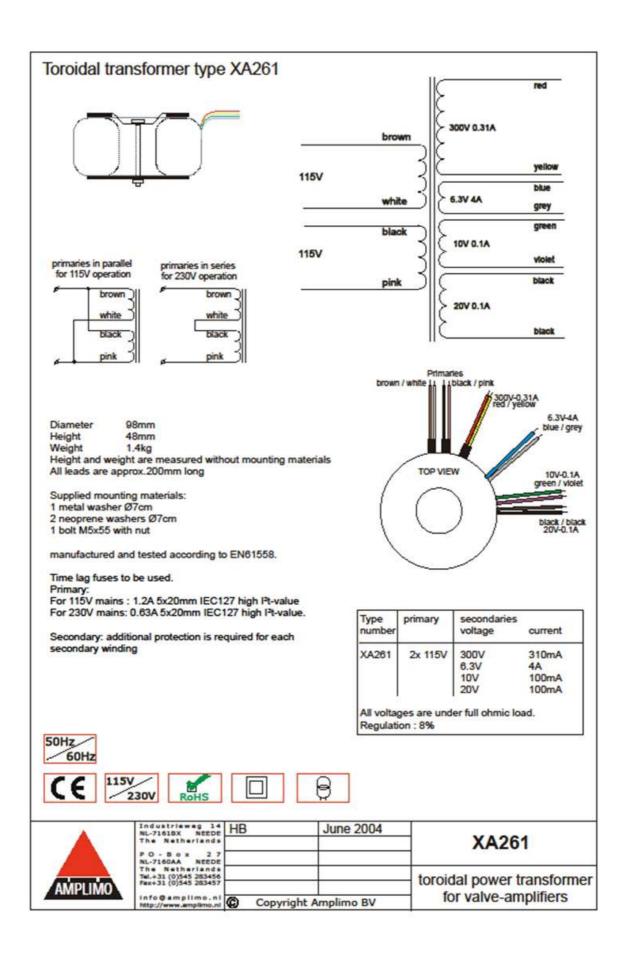
Datasheet of this toroidal transformer is available in the annexe.
